# Stormwater Dry Pond BMP Maintenance Log

Property: Villages at Crocketts Ridge

# Stormwater Wet Pond BMP Maintenance Log

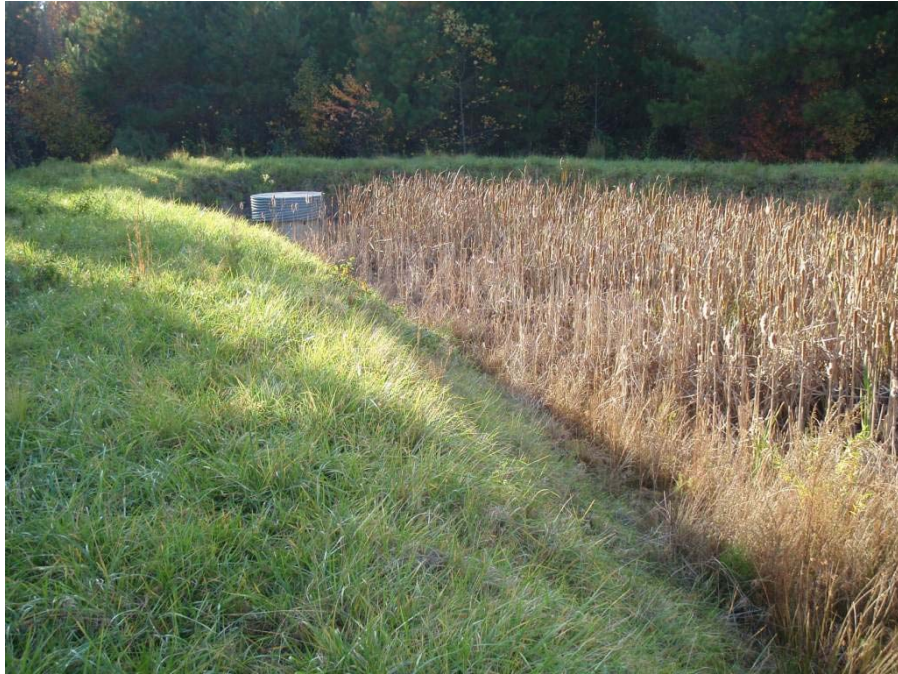
**11.5.08-** Dry pond functioning properly after recent rainfall.

View of dry pond (A) and wet pond (B), November 5<sup>th</sup>, 2008.

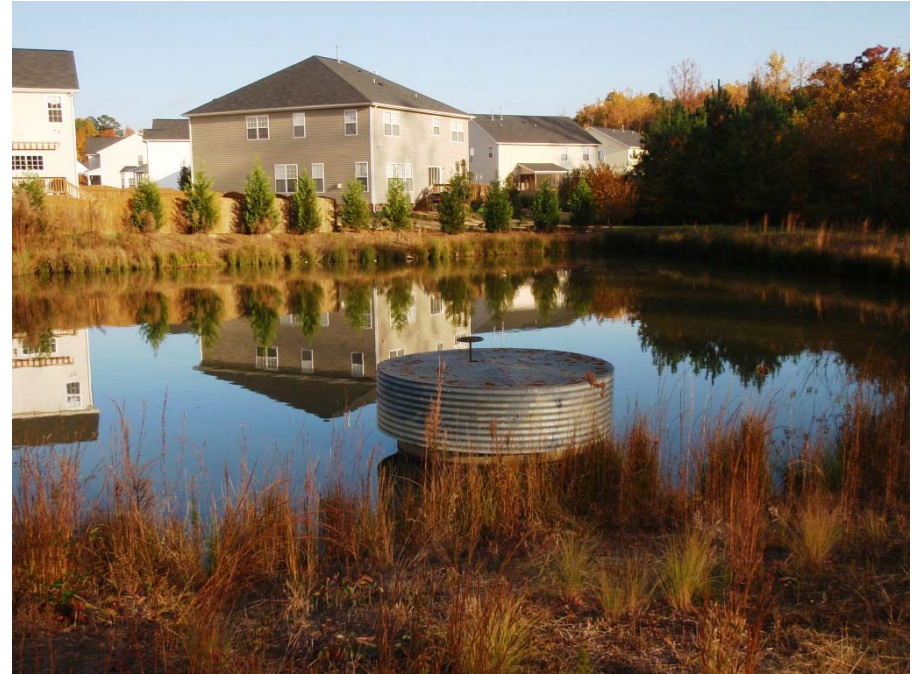
**11.5.08-** Pond functioning properly after yesterday's rain event. Added pond dye to enhance appearance. Vegetative buffer healthy, BMP functioning properly.
